Docket No. 217 – Development and Management Plan Inspection

Northeast Utilities Service Company Certificate of Environmental Compatibility and Public Need for the construction of a 345-kV electric transmission line and reconstruction of an existing 115-kV electric transmission line between Connecticut Light and Power Company's Plumtree Substation in Bethel, through the towns of Redding, Weston, and Wilton, and to the Norwalk Substation in Norwalk, Connecticut.

Date: July 6, 2005

Location: Norwalk Substation Expansion

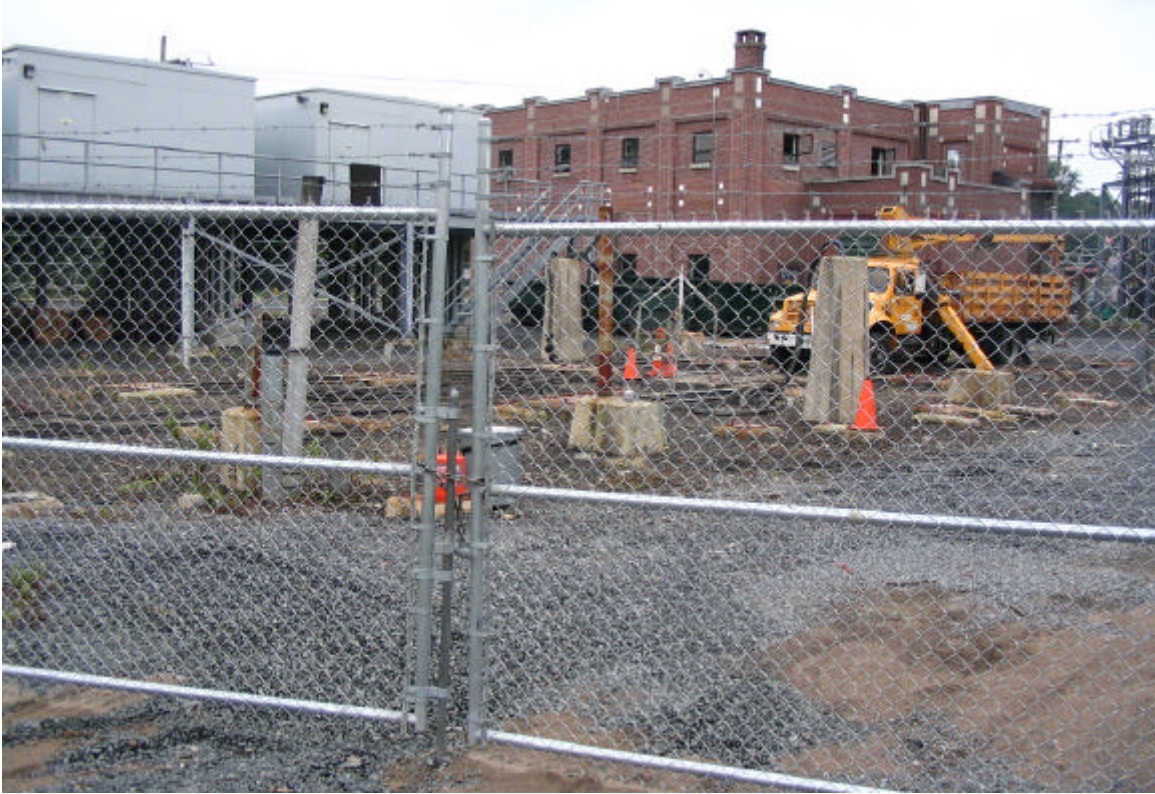
Norwalk Substation- The removal of old structures is occurring within the fenced yard in order to create new access. 7/6/05

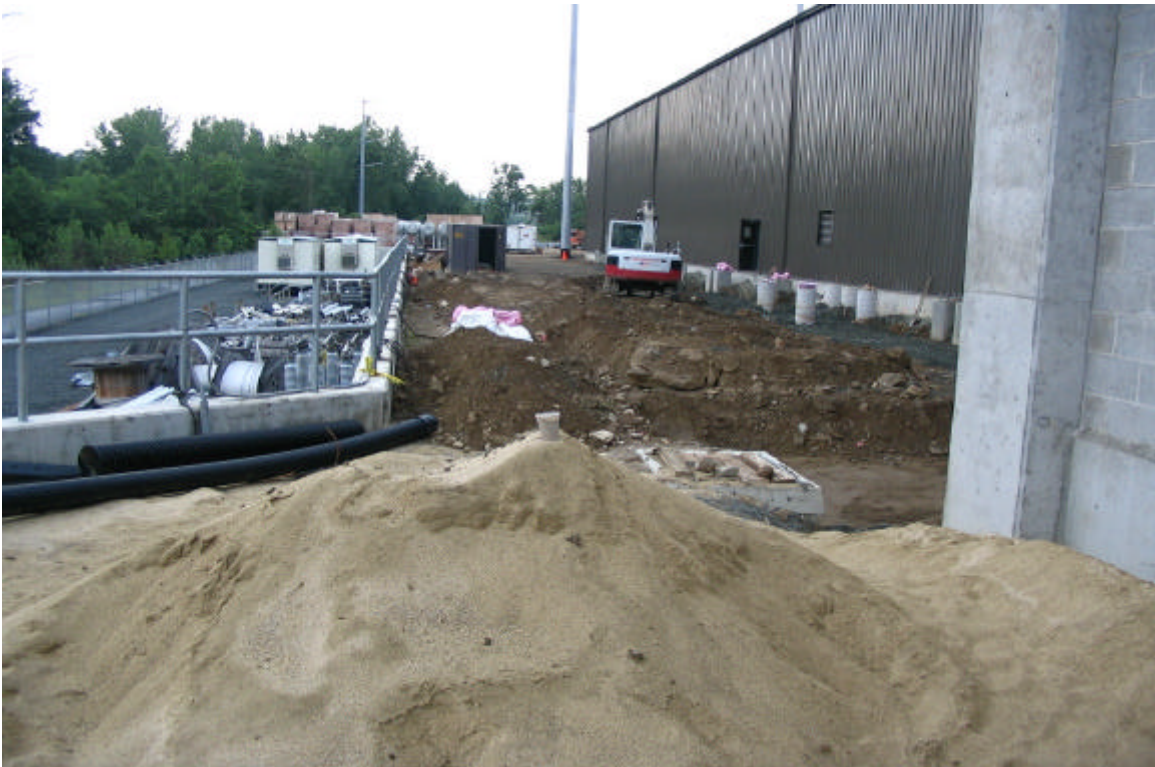
View of excavation, backfill and work behind the GIS building. 7/6/05

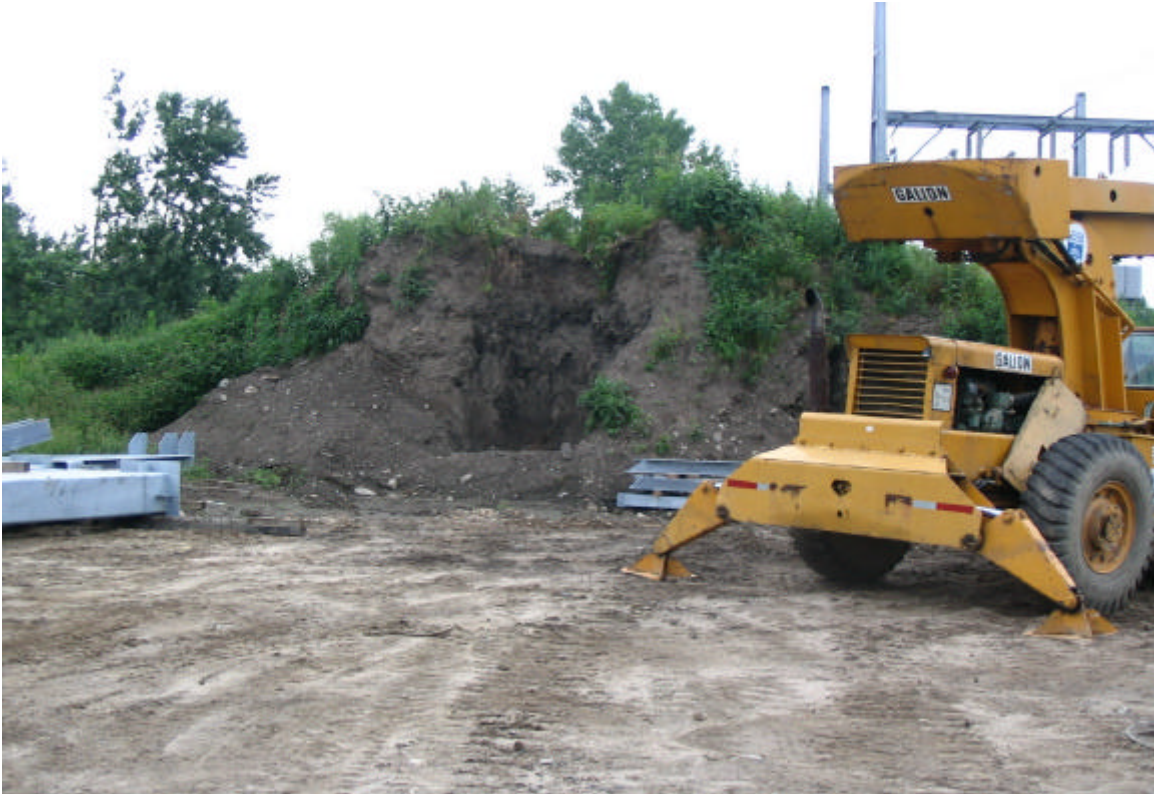
View of the topsoil pile which is being utilized in areas around the GIS building. 7/6/05

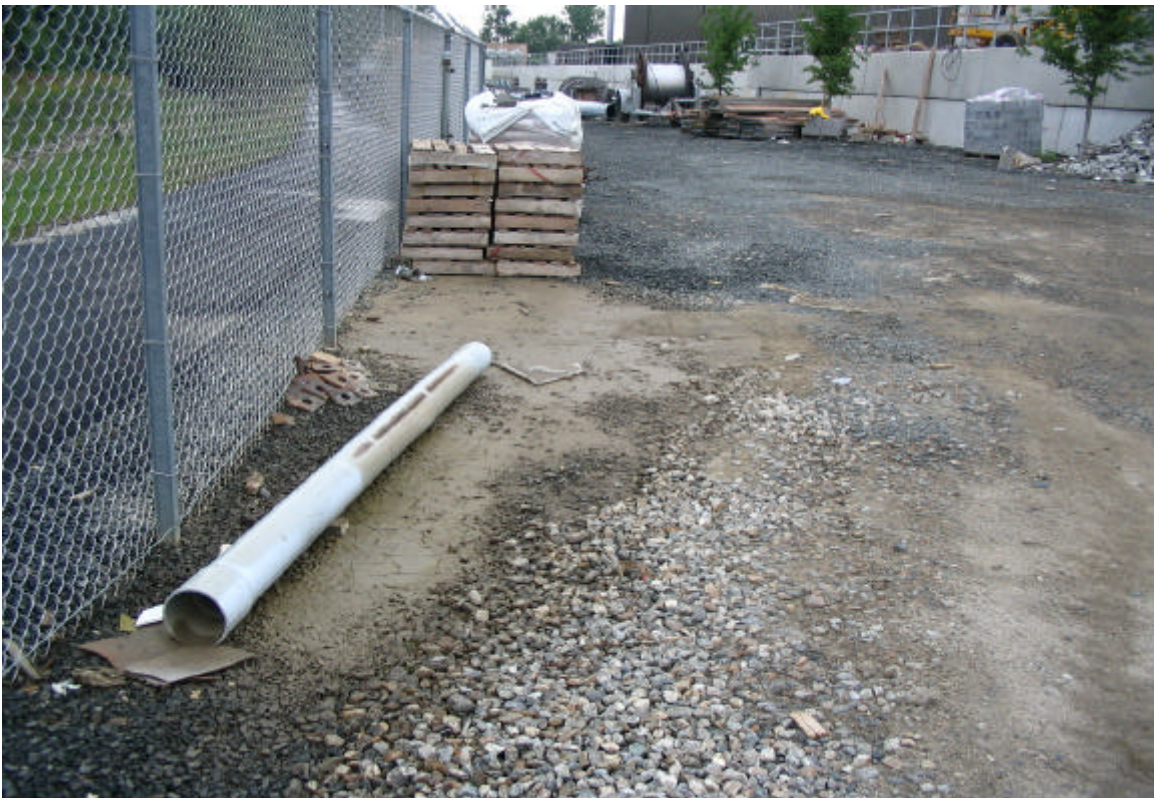
- Some sedimentation was noted at the base of the access road and it had piled up at the edge of the bike path. 7/6/05	- A stone berm at the base of the perimeter fence would prevent this sediment from reaching the bike path or overflow channel. 7/6/05

Some sediment from the access road has washed to the base of the perimeter fence. A stone berm placed here will likely keep it from migrating to the bike path. 7/6/05

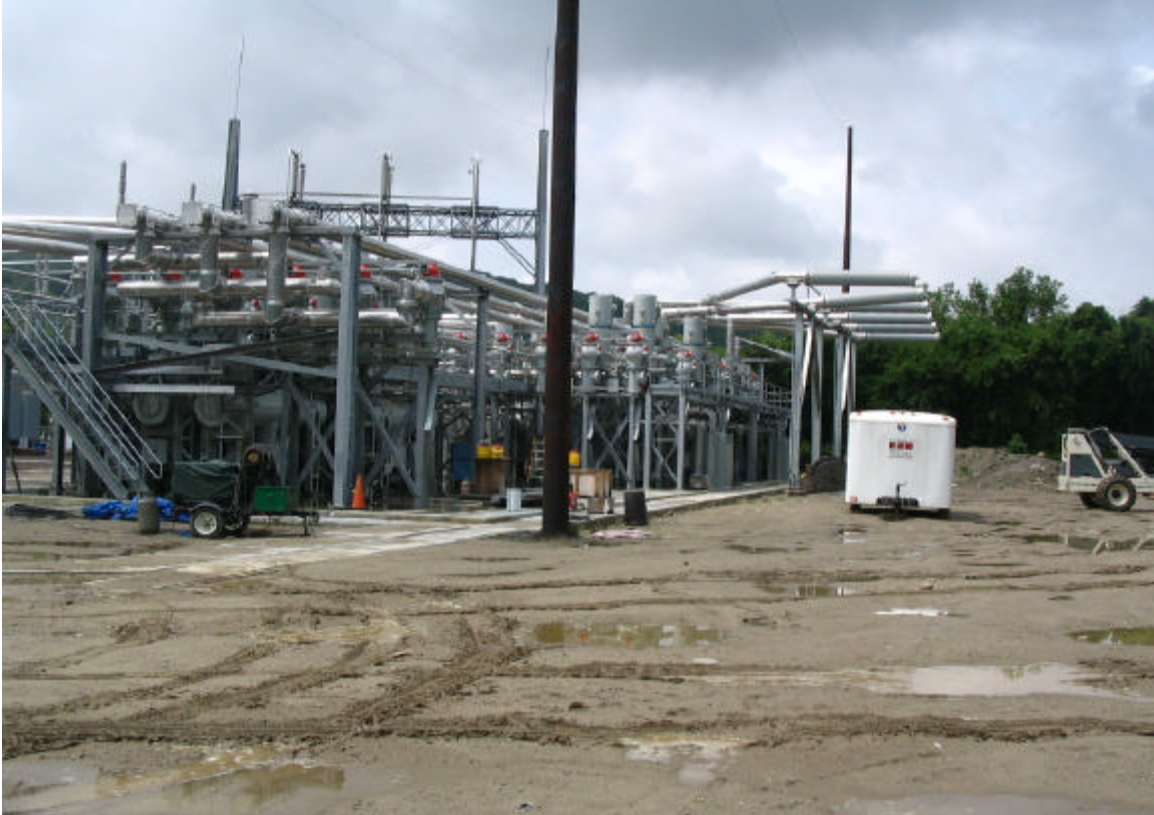
Plumtree Substation- Overview of the work on the concrete slab. 7/6/05

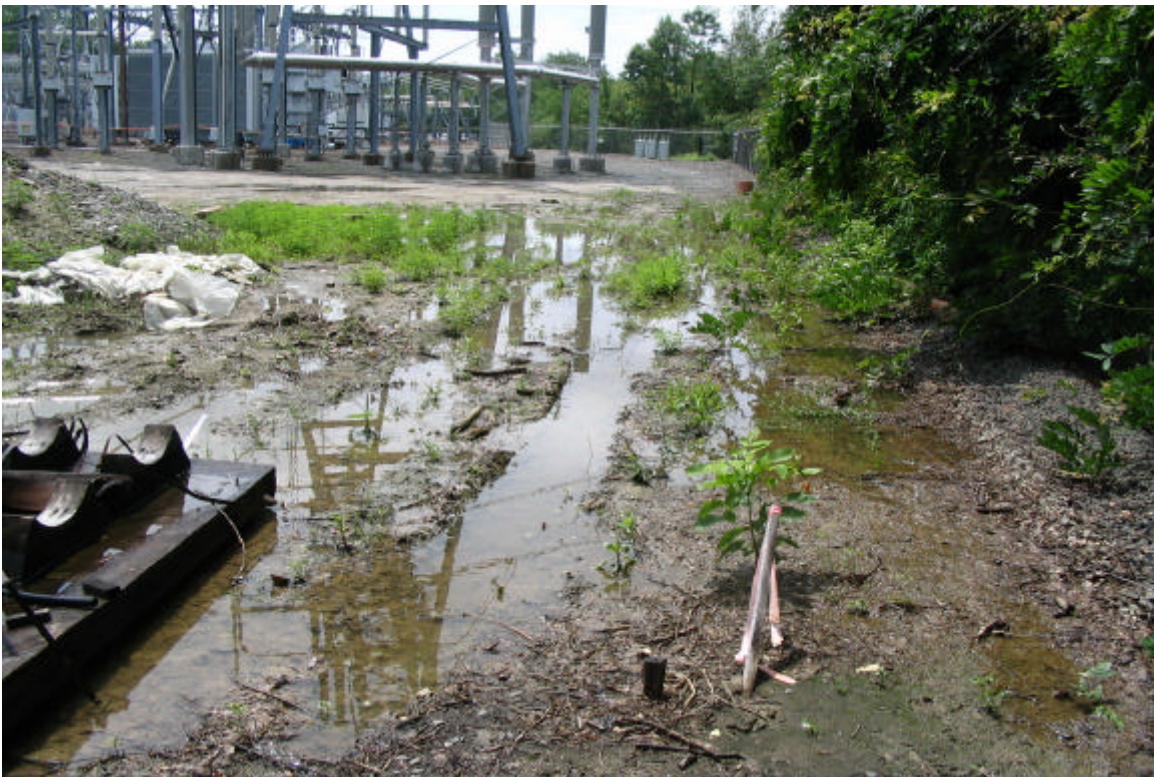
The perimeter berm continues to effectively prevent stormwater from leaving the site. 7/6/05
